Manhole Inspection Summary

Manhole # S33UU1014MH

Insp Date: **1/29/07 1:52 PM**

Location Address: **204 PADDINGTON RD**

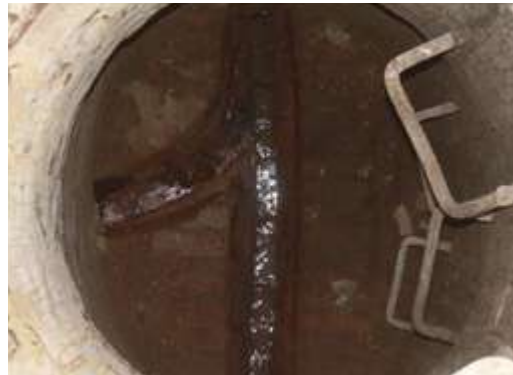
Top View

Evidence of surcharge - Bench debris.

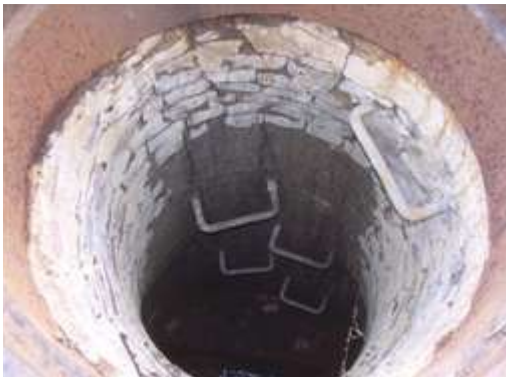
Defect

Frame leaks. Adjustment deterioration and infiltration. Corbel and Barrel infiltration.

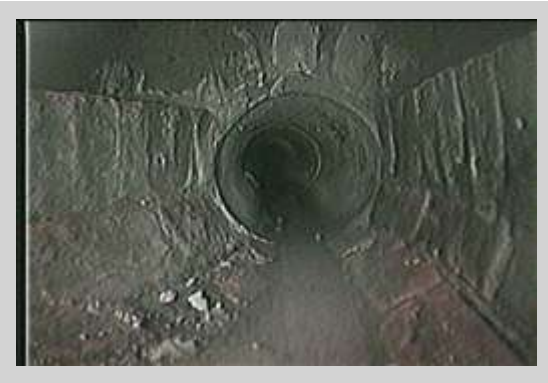
8 in. Circular Gravity Sewer Pipe Out @ 12 O'Clock

Channel deterioration.

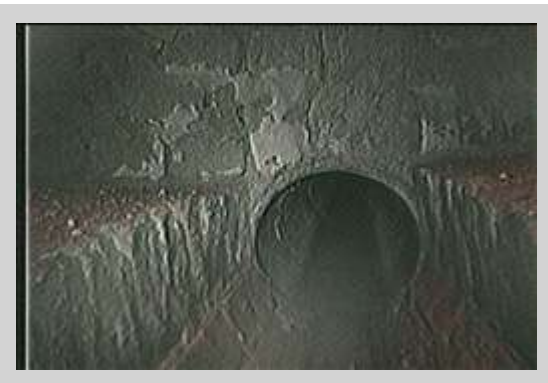
8 in. Circular Gravity Sewer Pipe In @ 7 O'Clock

Barrel deterioration and infiltration. Channel deterioration.

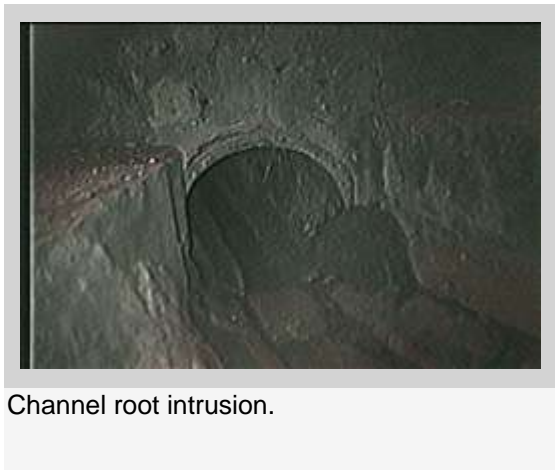
6 in. Circular Gravity Sewer
Pipe In @ 9 O'Clock

Infiltration: **Evidence** Pipe Seal Cond: **Unknown**
